AQUATIC ENVIRONMENT
OF
HUMBER BAY

Edited by M. Griffiths

Water Resources Branch
Ontario Ministry of the Environment

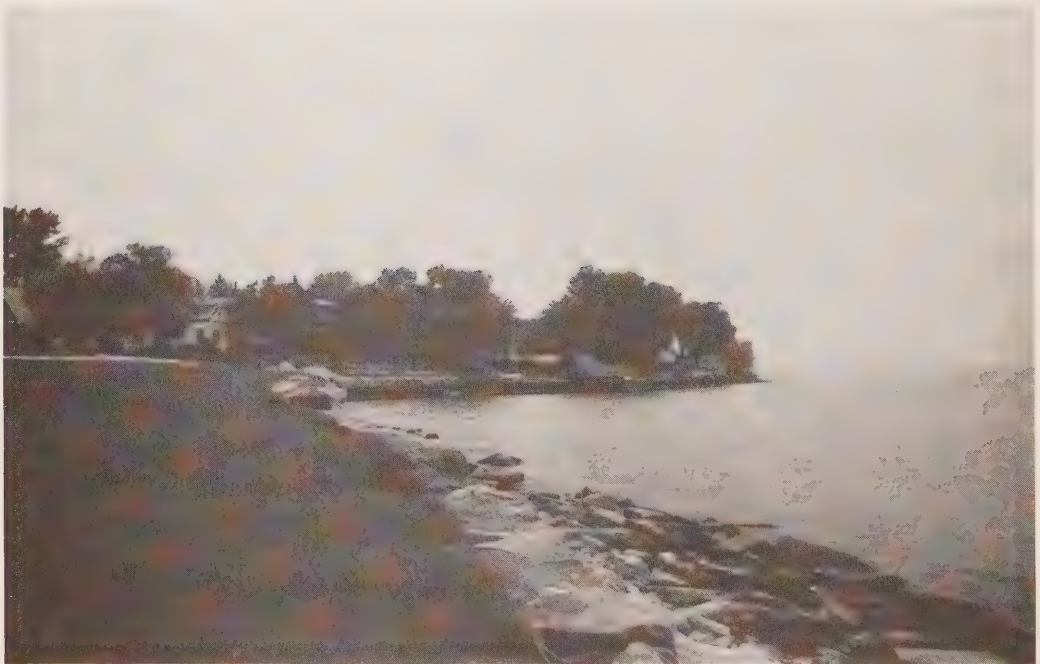
Boulders armouring this Etobicoke shoreline of Humber Bay provide a perfect substrate for the growth of a nuisance filamentous alga Cladophora.

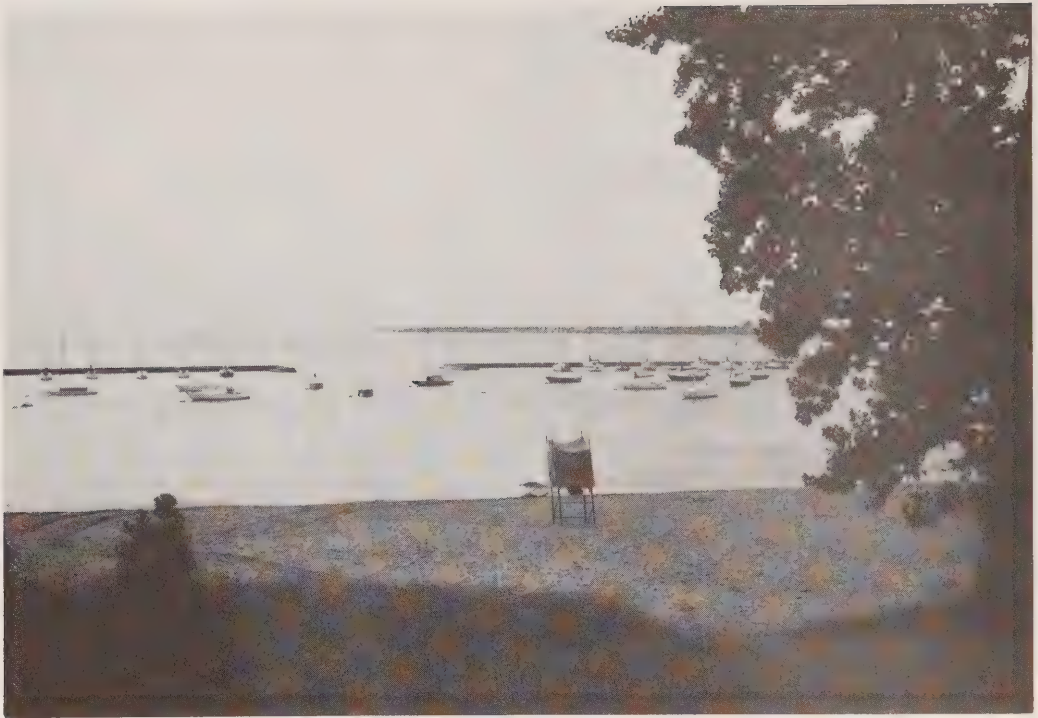
A series of breakwalls protects the Western beaches from wave activity and provides a quiescent environment for boat mooring.

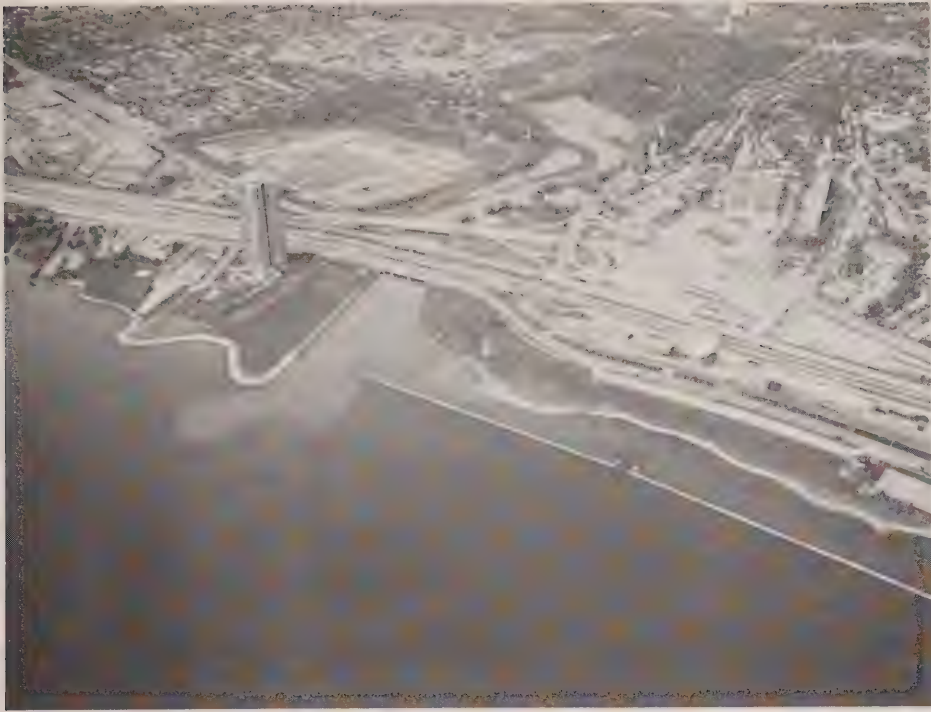
Humber River plume: Oct 18, 1983
 Note its intrusion behind the
 breakwall prior to the construction of
 a deflecting jetty.

The first evidence of the Humber River plume affecting the inner breakwater water quality came from aerial photographs. The surface river turbidity plume was observed to enter the breakwater at the river outlet and move eastward. A deflector jetty was constructed at the river mouth in late 1984. The jetty did not close off the breakwater gap entirely.

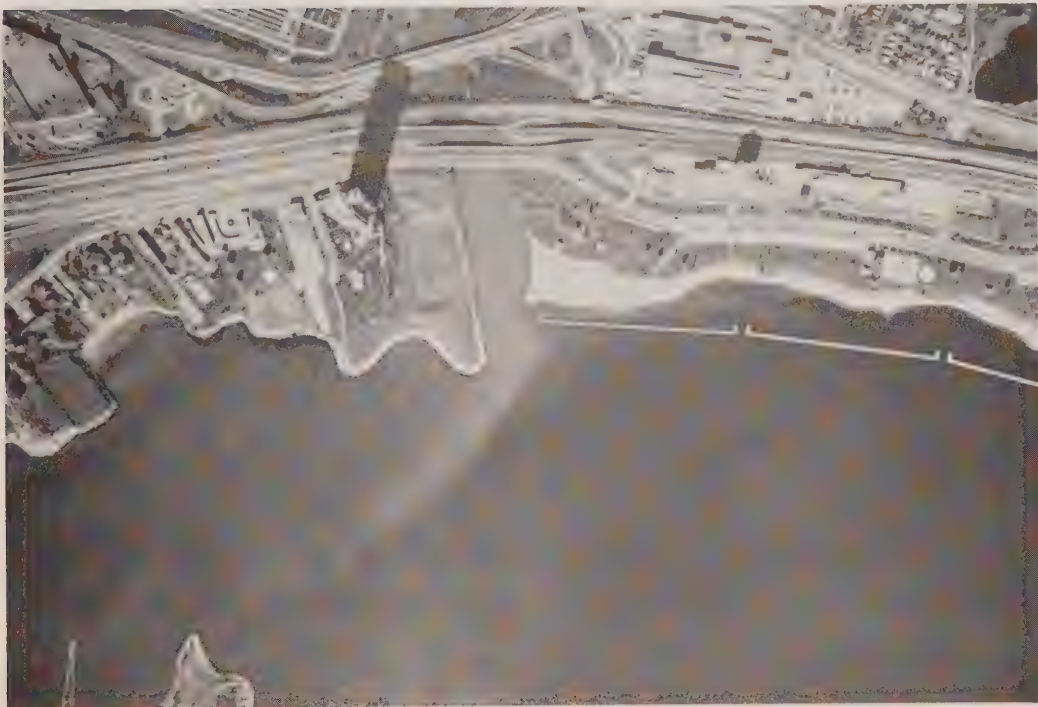
Humber River plume: Oct. 29, 1984
 Note the newly constructed jetty on the east side of the
 river mouth which now deflects the river away from the beach
 area. The dark circular blob visible in the bottom left of the
 photograph is the plume from the Humber STP which is impinging
 on the Humber Bay waterfront area.

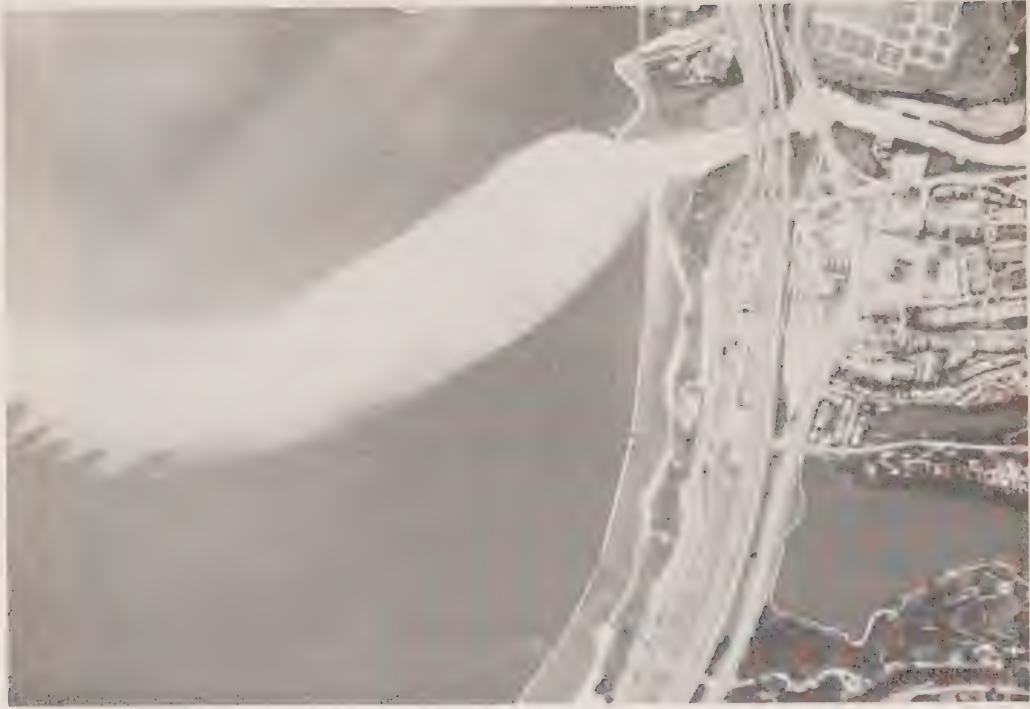
Humber River plume: 16 July, 1985
Runoff conditions coupled with strong
northerly winds have resulted in an
extensive plume on that day.

Subsequent aerial photographs have shown that the surface Humber River plume can still move through the gap and travel eastward. A time lapse video of the Humber River mouth (Hunter 1985) found intrusions as far as the third gap. The intrusion occurrences are listed below:

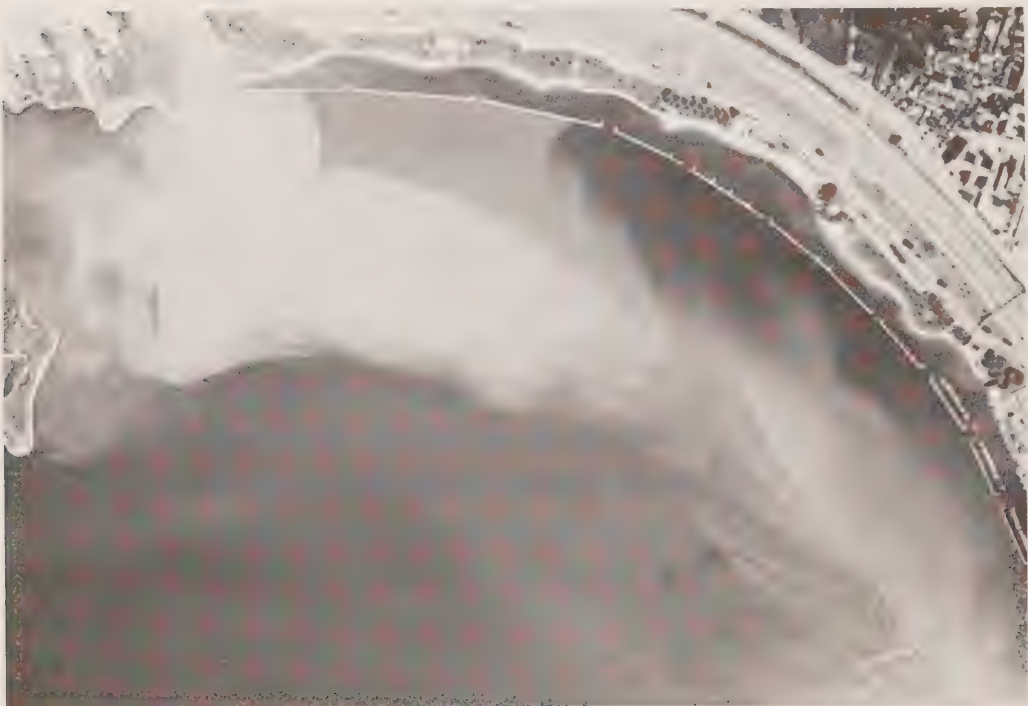
Humber River plume, 17 July, 1985
Note the dynamic nature of the
plume by comparing its configuration
with that photographed the previous day (above).

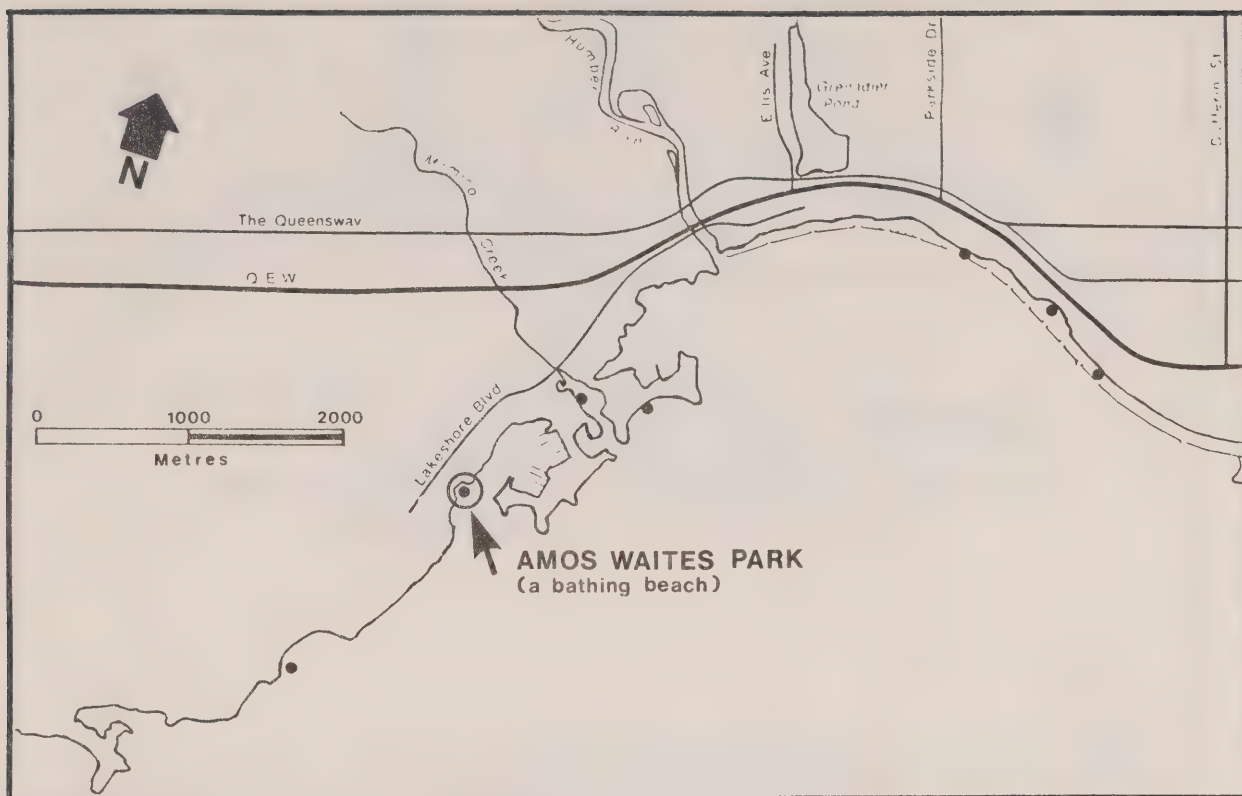
* Geometric mean significantly higher than PWQO (100 fecal coliforms/100 ml) at 95% confidence level.

FIGURE 3.2.4: HISTORICAL TRENDS (1972 - 1985) OF FECAL COLIFORM LEVELS AT AMOS WAITES PARK BEACH. (based on Dept. of Public Health Data)

A historical summary of Department of Public Health monitoring results based on fecal coliforms is presented in Figures 3.2.3 - 3.2.9. Note that out of the 7 monitoring sites only 3 are swimming beaches (Amos Waites, Sunnyside Beach and Boulevard Club). For purposes of assessing the relative bacterial impairment across the Humber Bay waterfront, the summer geometric means at each beach location were compared to the body contact recreation guideline of 100 fecal coliforms/100 mls. Note that an absence of guideline violations based on summer geometric mean comparisons does not necessarily indicate safe swimming conditions at a site since such health related decisions are made on daily basis relying on running geometric means and other related factors previously discussed.

In the 1972-1985 period, the summer geometric mean of fecal coliforms at swimming beaches significantly exceeded the 100 organisms/100 ml guideline for body contact recreation at Amos Waites in 1982 and 1983 and at Sunnyside in 1982. Although summer geometric means above the 100 fecal coliforms/100 mls guideline were also noted in 1985 at Amos Waites Park Beach and in 1977, 1984 and 1985 at Sunnyside Beach, none

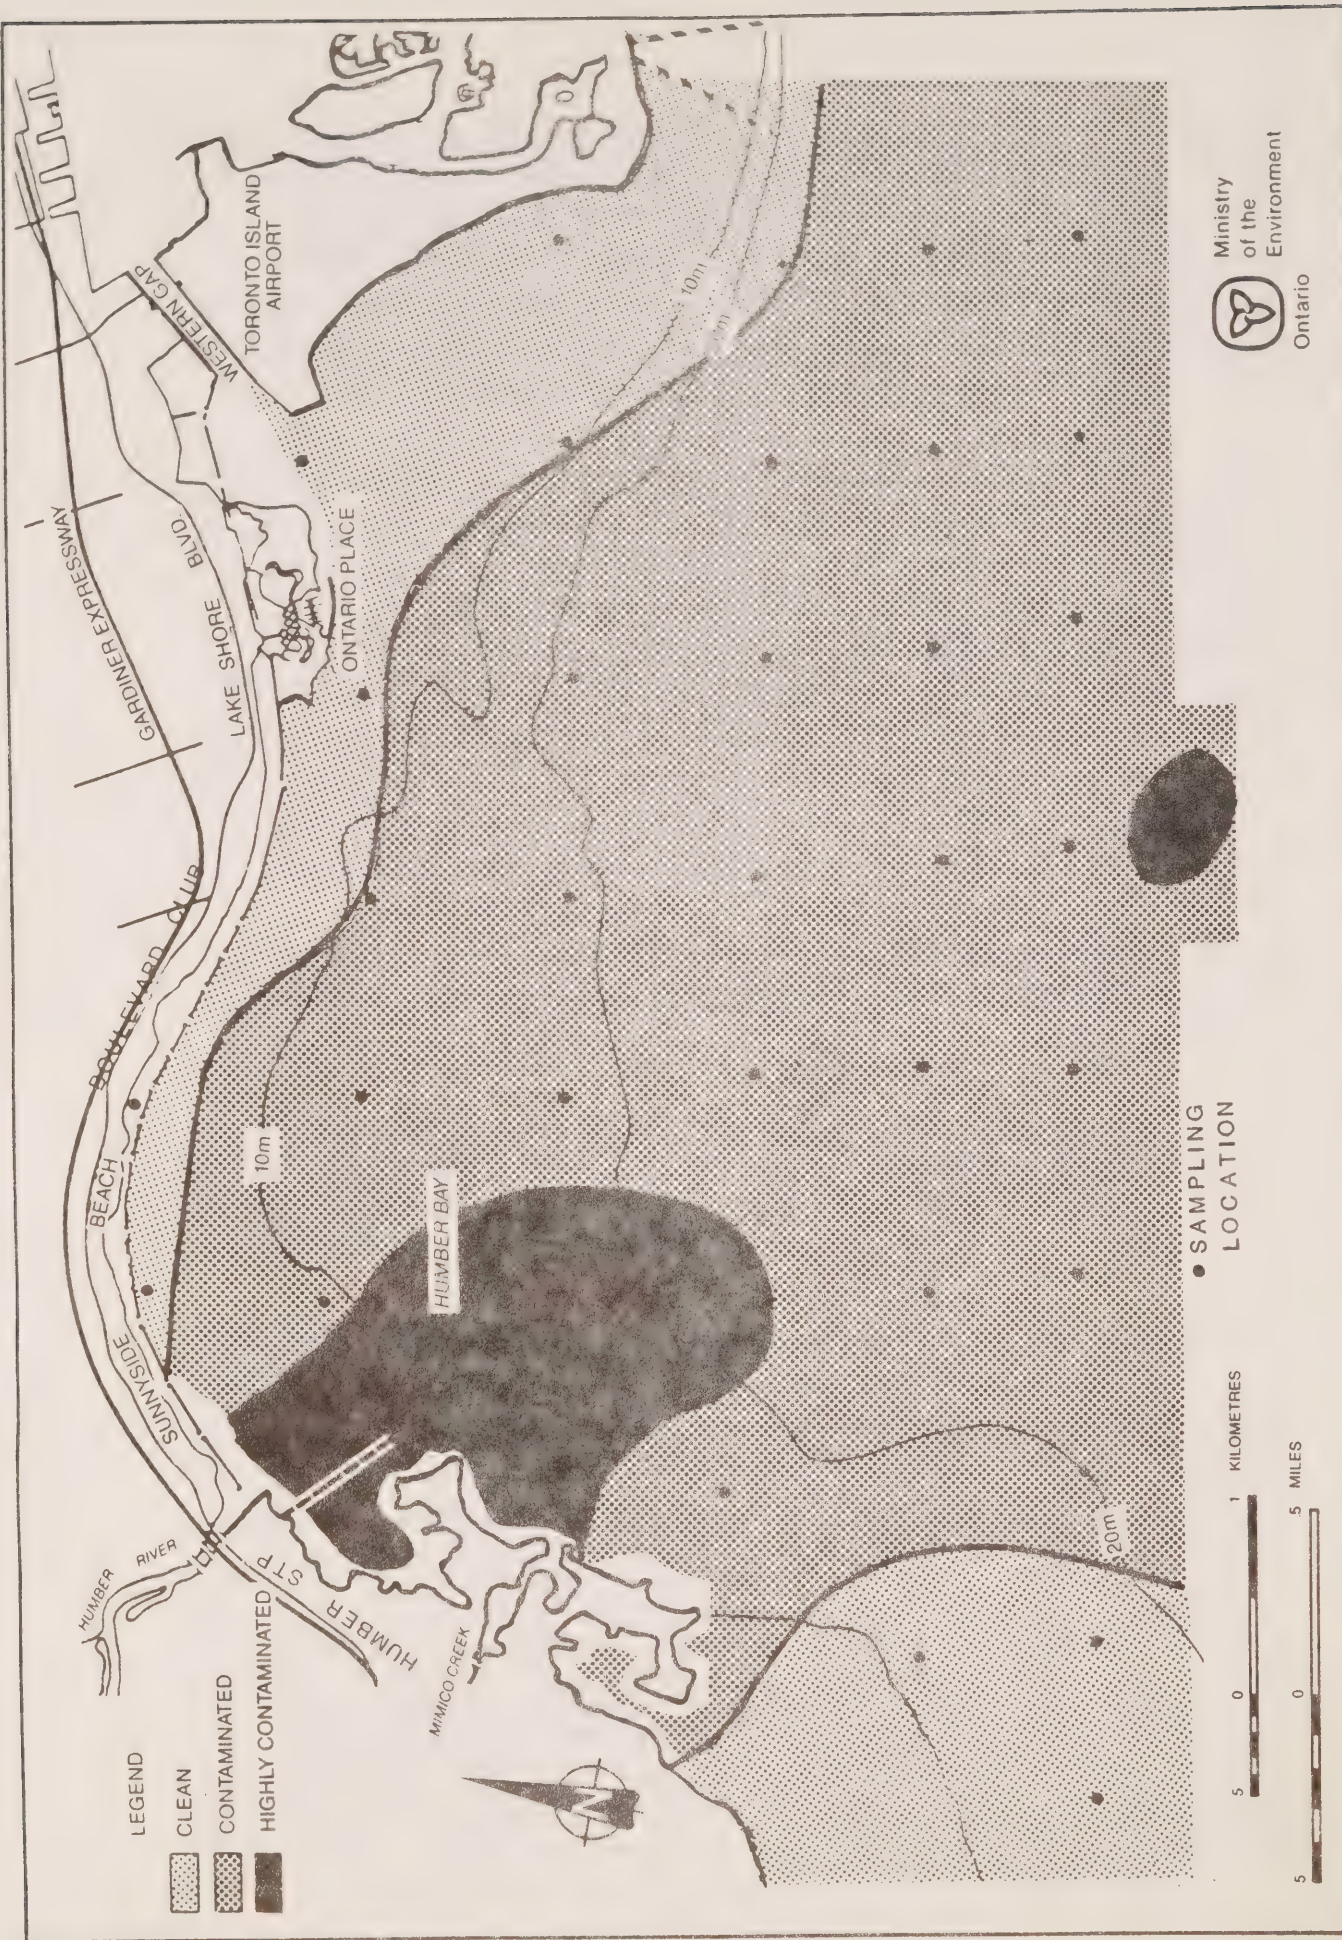
FIGURE 3.3.1 SEDIMENT QUALITY ZONES WITHIN HUMBER BAY, 1979 SURVEY.

Based on 1979 results, the sediment type and sediment quality in Humber Bay could be delineated into three zones. A strip of coarse (sand), clean material was identified along the shoreline on the west side of the Toronto Islands continuing over to Sunnyside Beach. As well, pockets of coarse, clean, material were found to the west of the Bay. Fine (silts and clays), contaminated material was found in the inner portion of the Bay extending lakeward. The sediment sampled in this area was contaminated with organic material, nutrients, metals, solvent extractables and PCBs. The highly contaminated zone was the area extending from the Humber River around the Humber Sewage Treatment Plant outfall over to Mimico Creek. This fine material was highly contaminated with the above mentioned parameters. (Figure 3.3.1). Table 3.3.1 summarizes mean concentrations of several key parameters in the three zones.
